Prepared for the US General Services Administration

Oak Ridge National Laboratory

January 2015

# Catalyst-Based Nonchemical Water Treatment System Frank E. Moss US Courthouse Salt Lake City, Utah

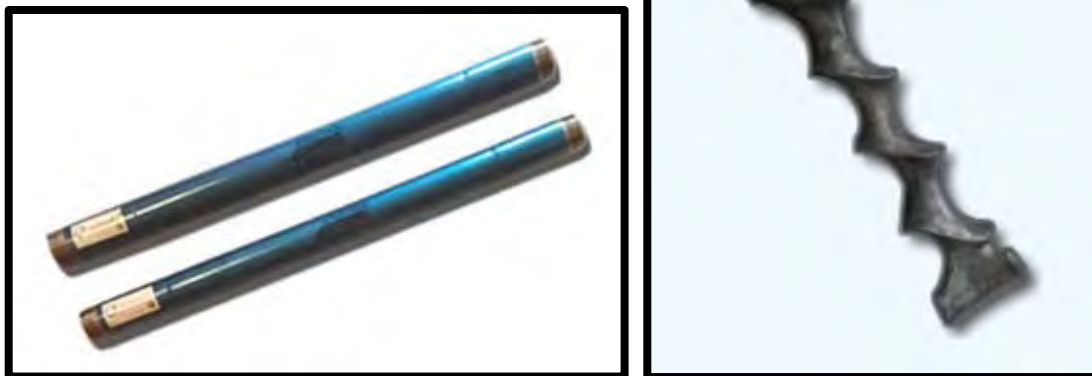
Figure ES-1 shows photographs of the device’s components. The image on the left shows what the exterior looks like. The image on the right shows the helical insert made out of the catalytic alloy. (Photo images were copied from the manufacturer’s website.)

**Figure ES-1. Novel Nonchemical Water Treatment System. No external energy sources are required to operate this device. Periodic maintenance issues that must be addressed are also minimal. Once installed, the system operates as a stand-alone device. The vendor reports that the system has a service life of 15–20 years.**

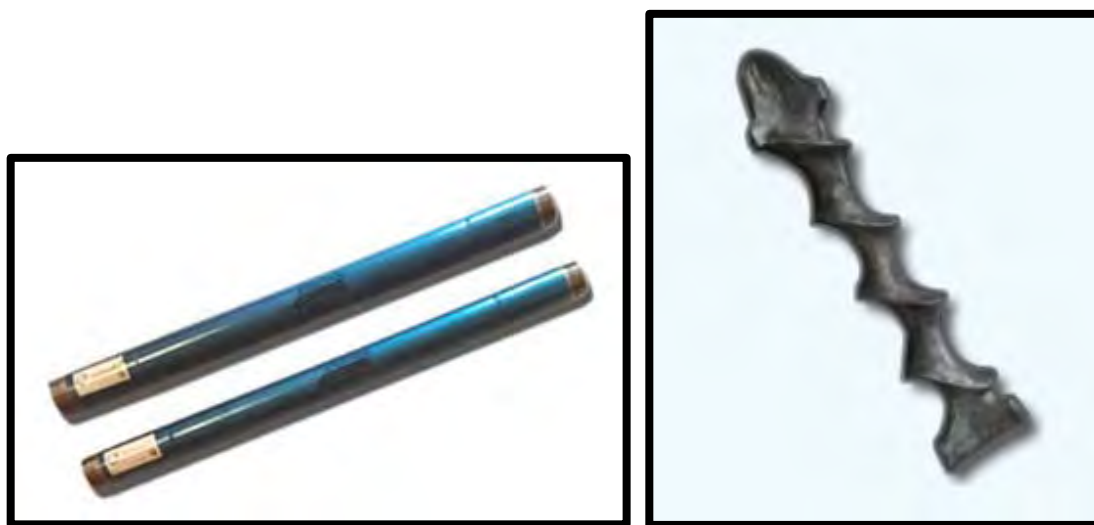
Figure 1 shows photographs of the device's components. The image on the left shows what the exterior looks like. The image on the right shows the helical insert made out of the catalytic alloy. (Photo images were copied from the manufacturer's website.)

**Figure 1. Novel Nonchemical Water Treatment System. No external energy sources are required to operate this device. Periodic maintenance issues that must be addressed are also minimal. Once installed, the system operates as a stand-alone device. The vendor reports that the system has a service life of 15–20 years.**

Inside the pipe is a fixed, immobile helical insert that is made from a proprietary catalytic alloy. As water passes through the pipe, the helical shape causes significant turbulence, which in turn allows water molecules and their associated chemicals to brush against the catalytic insert. According to the manufacturer, as water enters the pipe it impacts with the turbulator on the front end of the alloy. This turbulence causes calcium carbonate to form from the calcium and carbon in the source water. As this calcium carbonate forms and comes in direct contact with the alloy, the properties of the alloy cause it to

form in its Aragonite state, which is a state of calcium carbonate which lacks the properties to adhere to any surfaces. As the water leaves the pipe it is saturated with Aragonite crystals of calcium carbonate, thereby eliminating the possibility of scaling in the system after treatment.

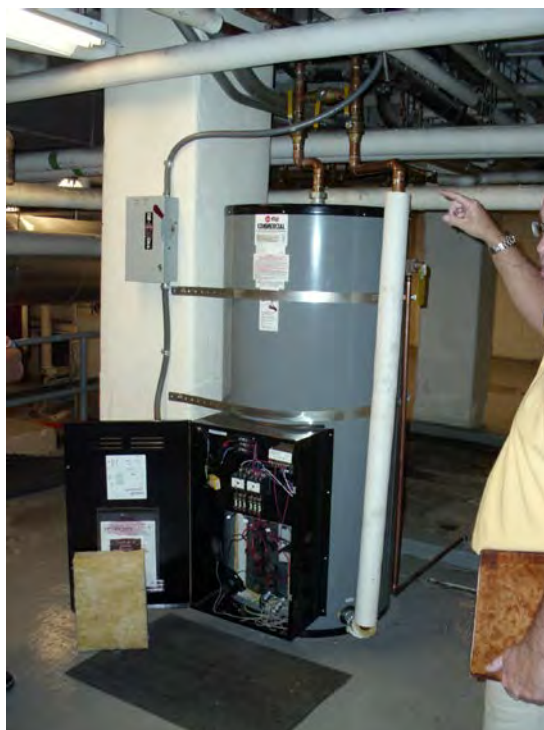
Figure 2 is a photograph of the electric water heater where the test was conducted. The insulated line on the right side is where the system's cold and recirculating water enters the tank.

**Figure 2. Electric Water Heater Where Test Was Conducted.**

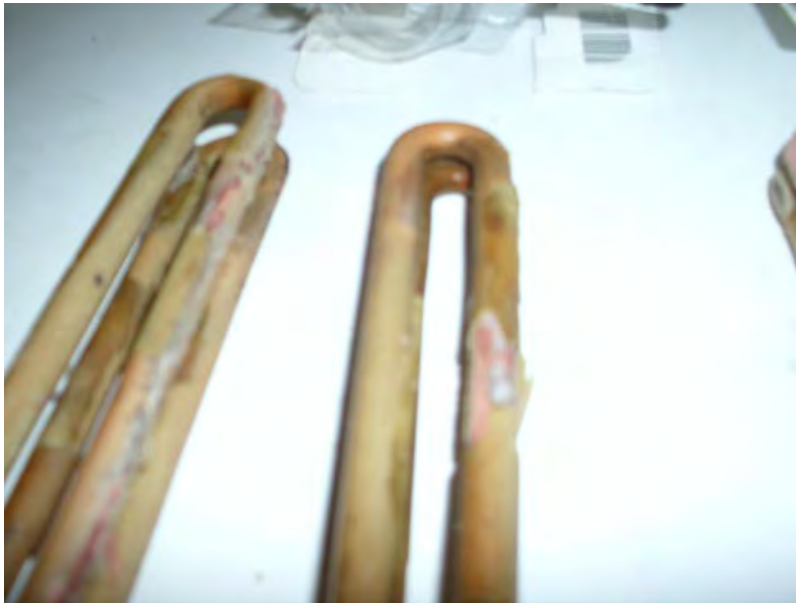
Figure 4 is another photo of a heating element taken at the moment it was removed from the tank. Please note the thickness of the calcite coating. It appears green in this photo due to it still being wet. This buildup was caused after just two months of operation in the tank.

**Figure 4. Heating Element Removed from the Electric Water Heater.**

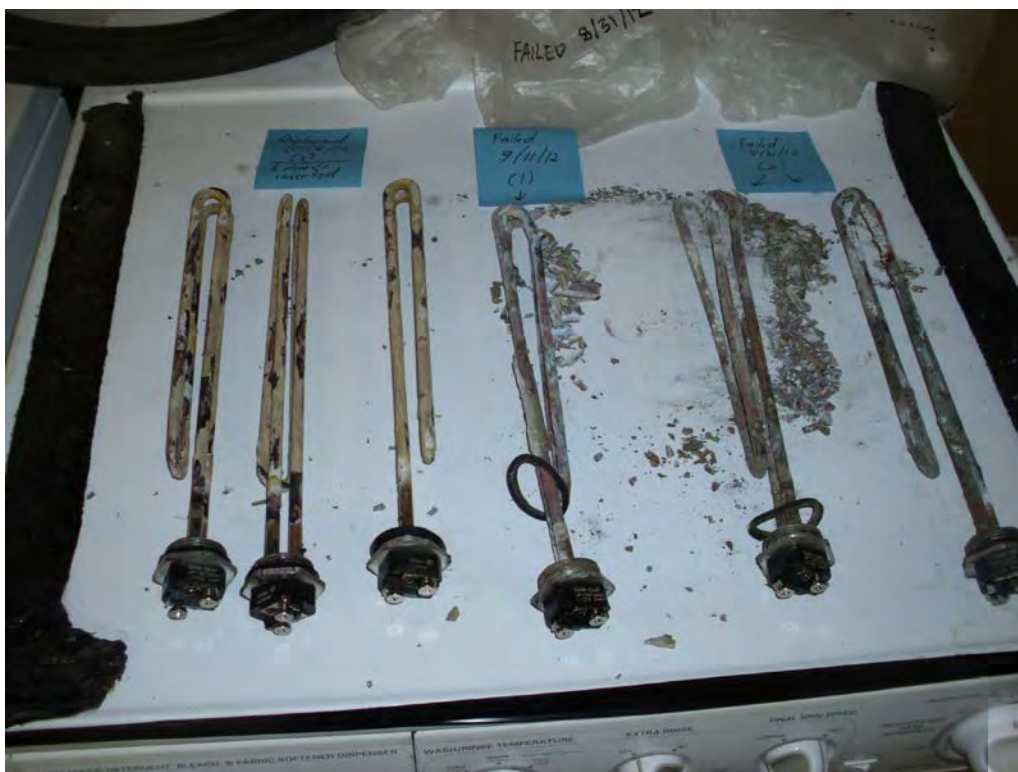
Figure 5 shows all six heating elements, which were removed by site operations personnel during one of the repair sessions. Three elements had failed, and all were severely coated with calcite.

**Figure 5. All Six Heating Elements Removed from the Electric Water Heater During a Repair Session.**

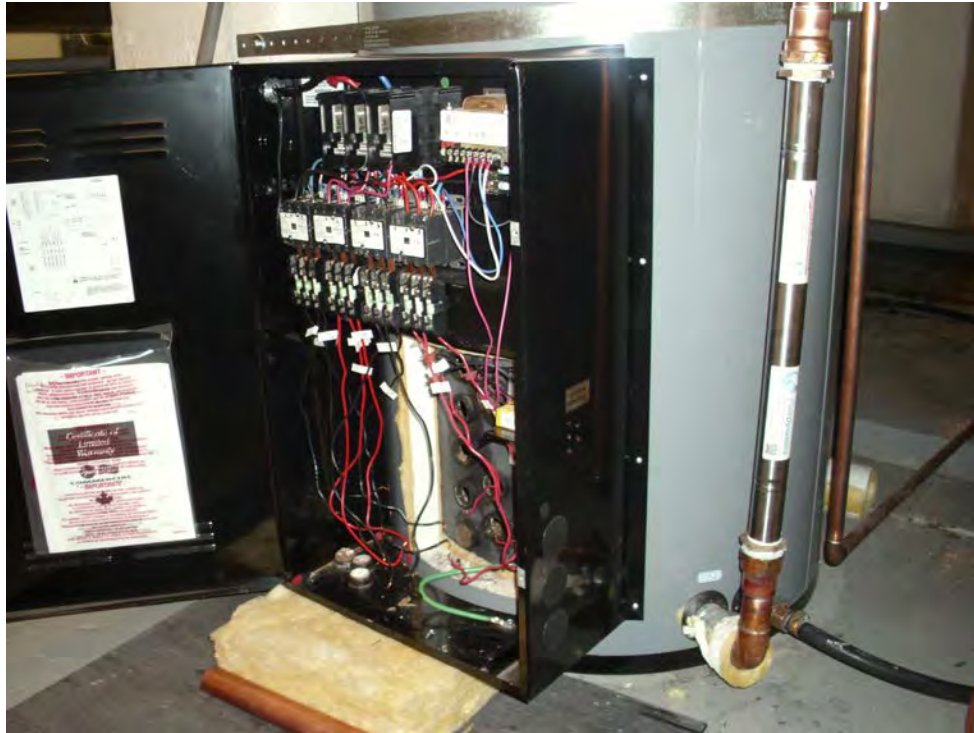
Figure 6 shows the device in its final configuration. It is the silver section of pipe on the right side of the black panel box. This is the cold water inlet to the water heater tank.

**Figure 6. Final Configuration for the Nonchemical Water Treatment System (silver section of pipe on the cold water inlet to the water heater tank).**

Installation of this technology is very straight forward. A section of the cold water and recirculating line was removed, appropriate pipe fittings were installed, and the technology was installed just as any pipe spool piece would be installed. Labor to install the device was only \$500 (10 person-hours at \$50/hr).

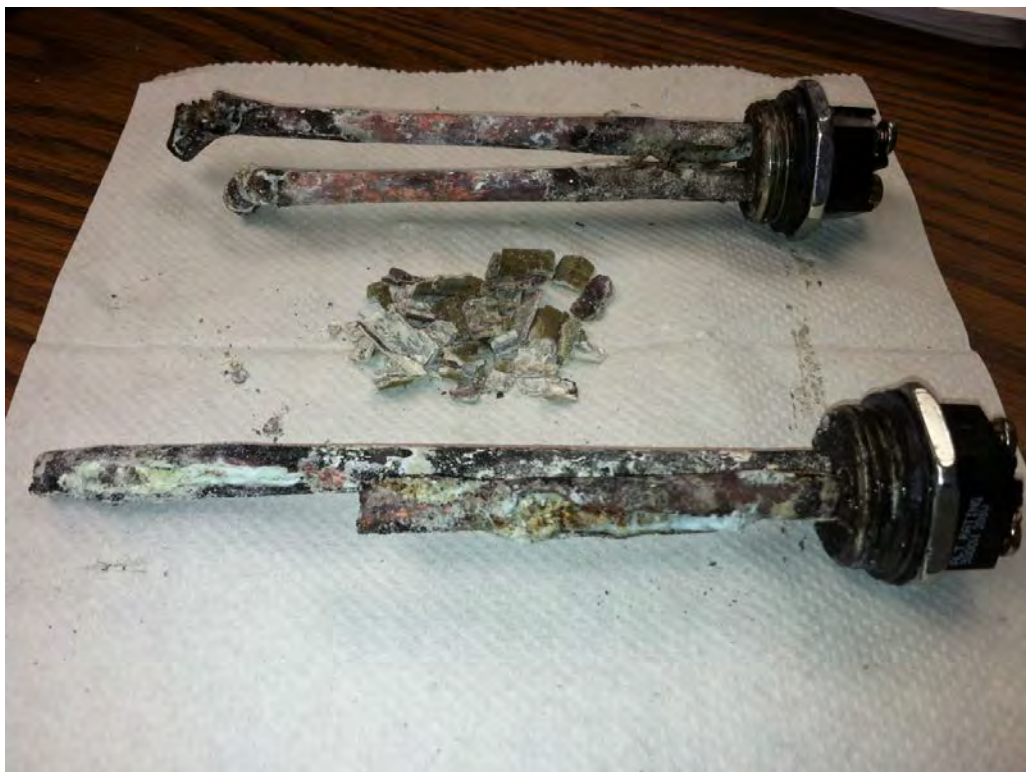
In December 2012, the GSA building manager contacted ORNL to say that it appeared that all three elements had again failed and ask for further guidance on what to do. After consultation with the project team, the elements were removed and their condition documented. Figure 7 shows two of the three failed elements.

**Figure 7. Two of the Three Failed Heating Elements from December 2012.**

The failure mode was the same as during the “before” test. Excess calcium buildup caused overheating and premature failure of the elements.

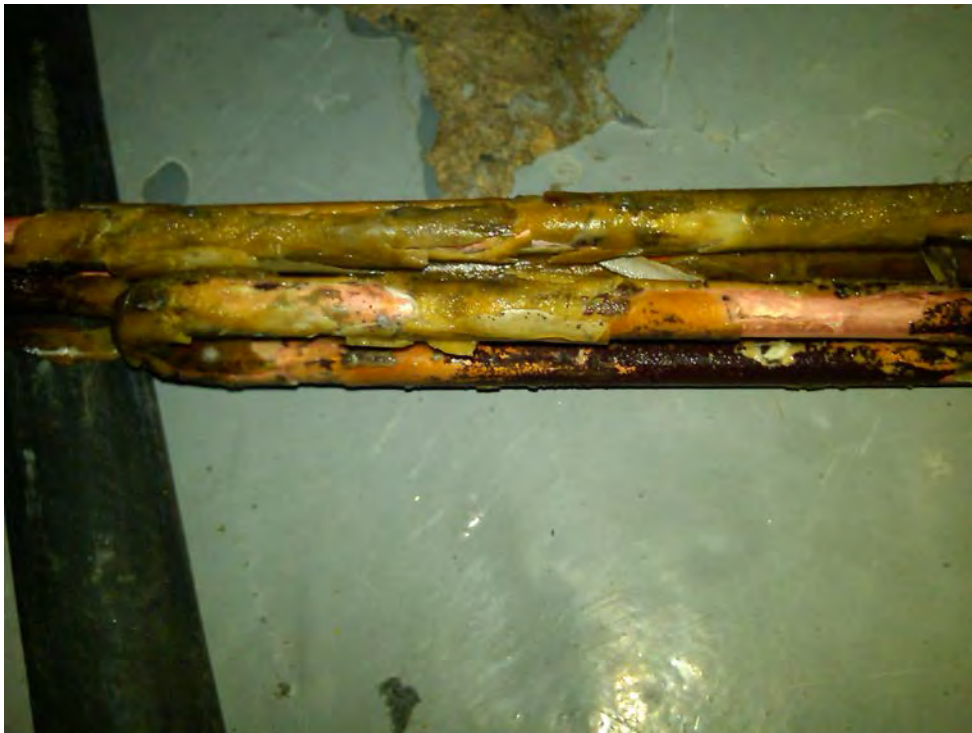
The heating elements that were removed all showed severe buildup of calcite, and this was after only two months of operation. They also showed signs of overheating and bending, which are precursors of failure (Figure 8).

**Figure 8. Heating Elements Removed June 2013.**

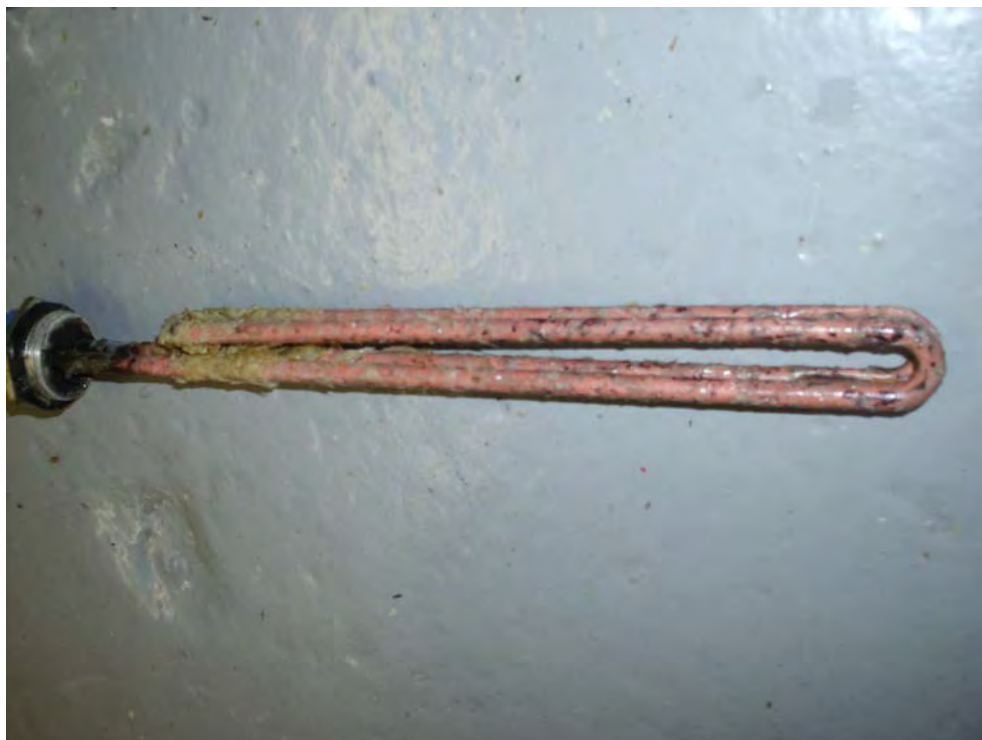
On August 20, 2013, the team met in Salt Lake City to examine the elements for calcium buildup. The six elements were removed, and they were indeed dramatically cleaner than had been seen in the past. Most of each element was bare metal with no buildup whatsoever. What calcium was found on the elements was in the form of very thin flakes. Also, there was no evidence of overheating or warping, which indicates there is no reason to fear impending failure of these elements (Figure 12).

**Figure 12. One of the Six Elements Examined August 20, 2013.**

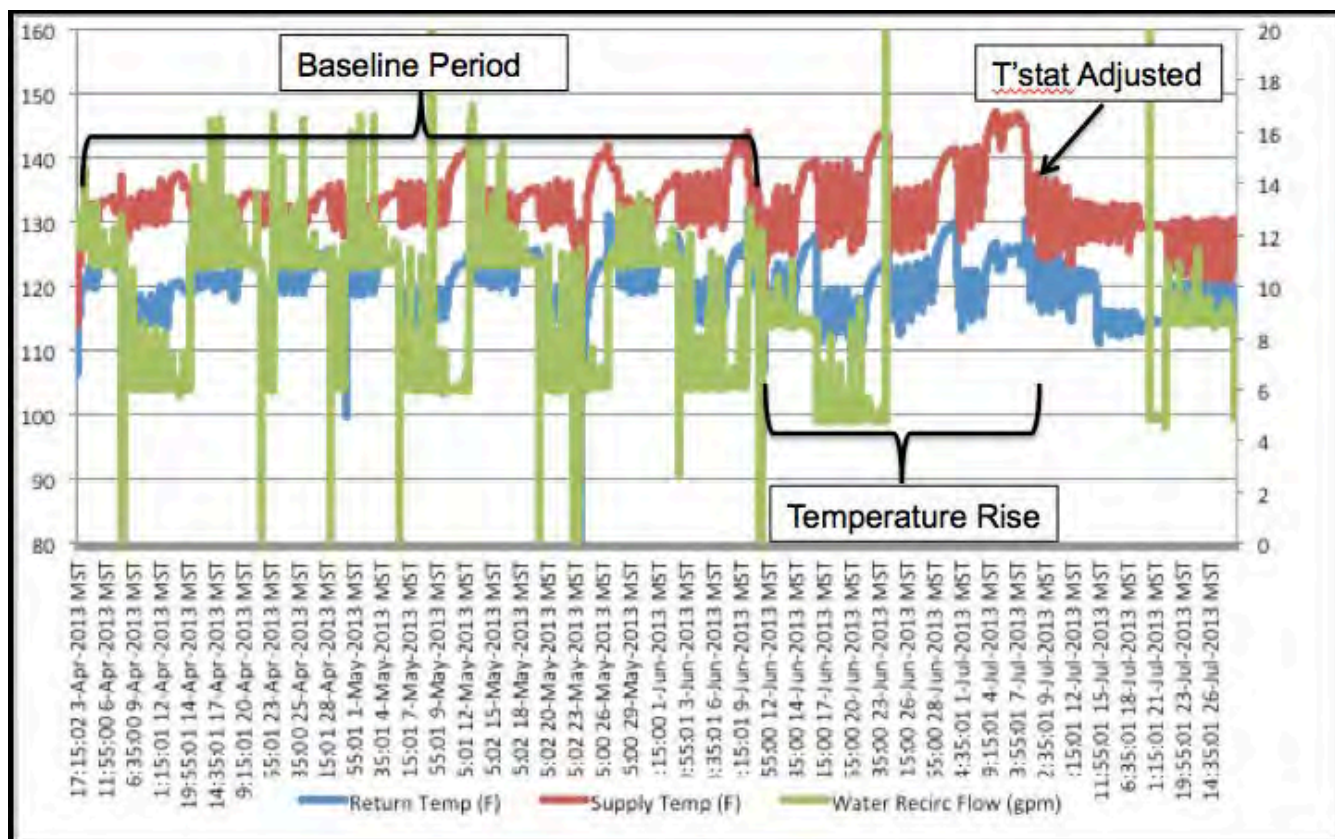
## B. Enlarged Flow Rate and Temperature Graph

The following is an enlarged image of Figure 10 from the main body of the report. It is being shown here for clarity's sake.
